ERDC TR-01-17

## **Seismic Testing of a 1/20 Scale Model of Koyna Dam**

November 2001

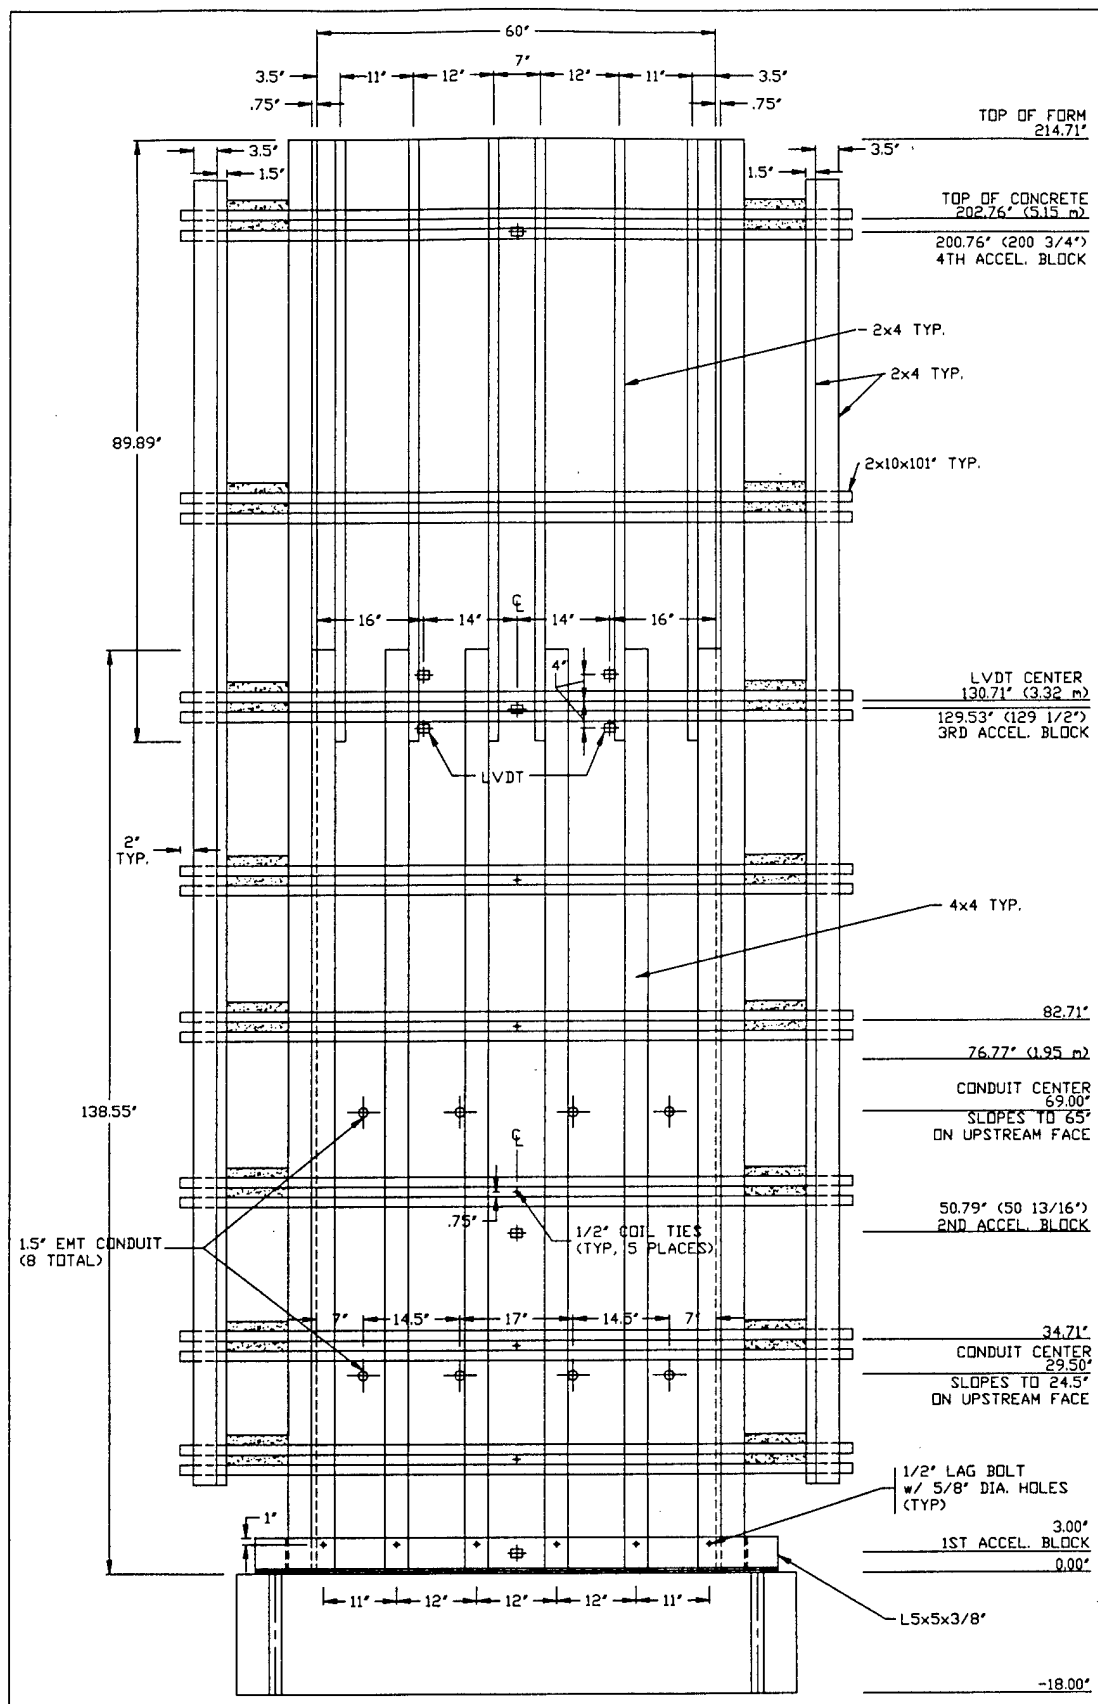
Figure A9. Downstream face formwork showing the walers, corners, and the location of ties, EMT conduit, and instrumentation plates.

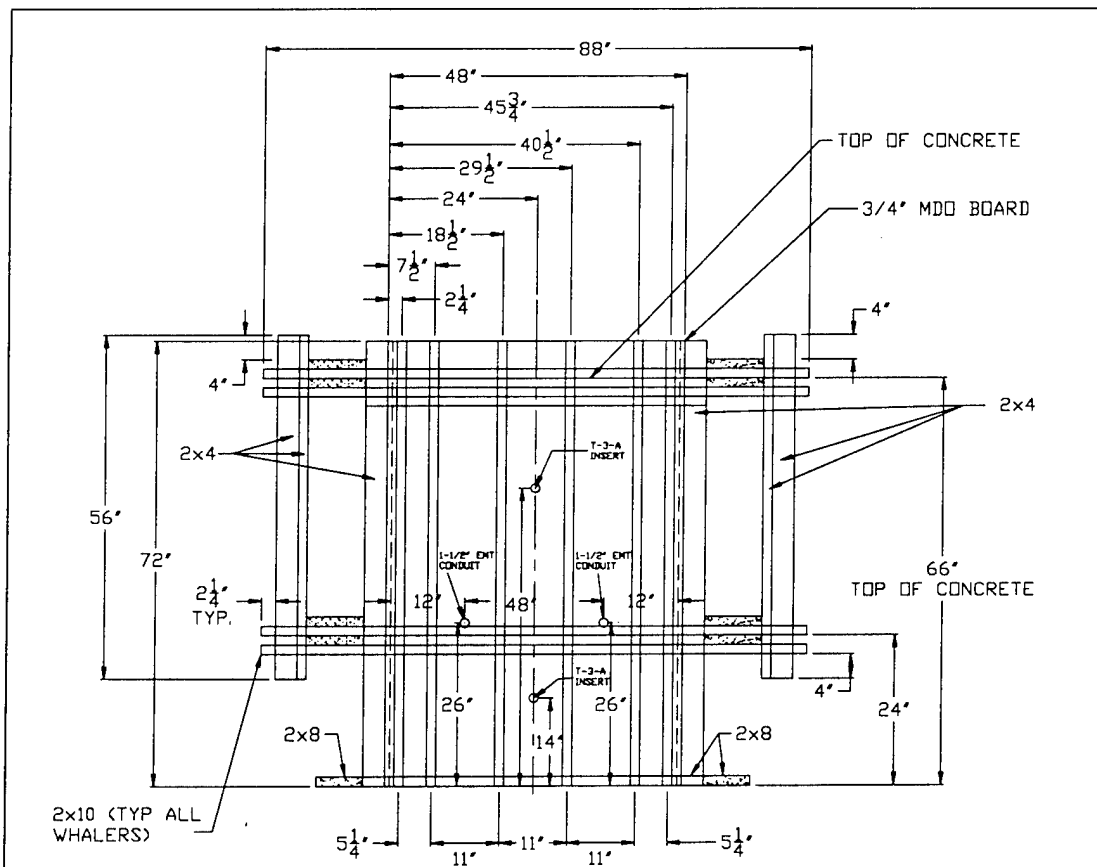
Figure A11. Front elevation view of test block formwork, including insert and EMT locations.

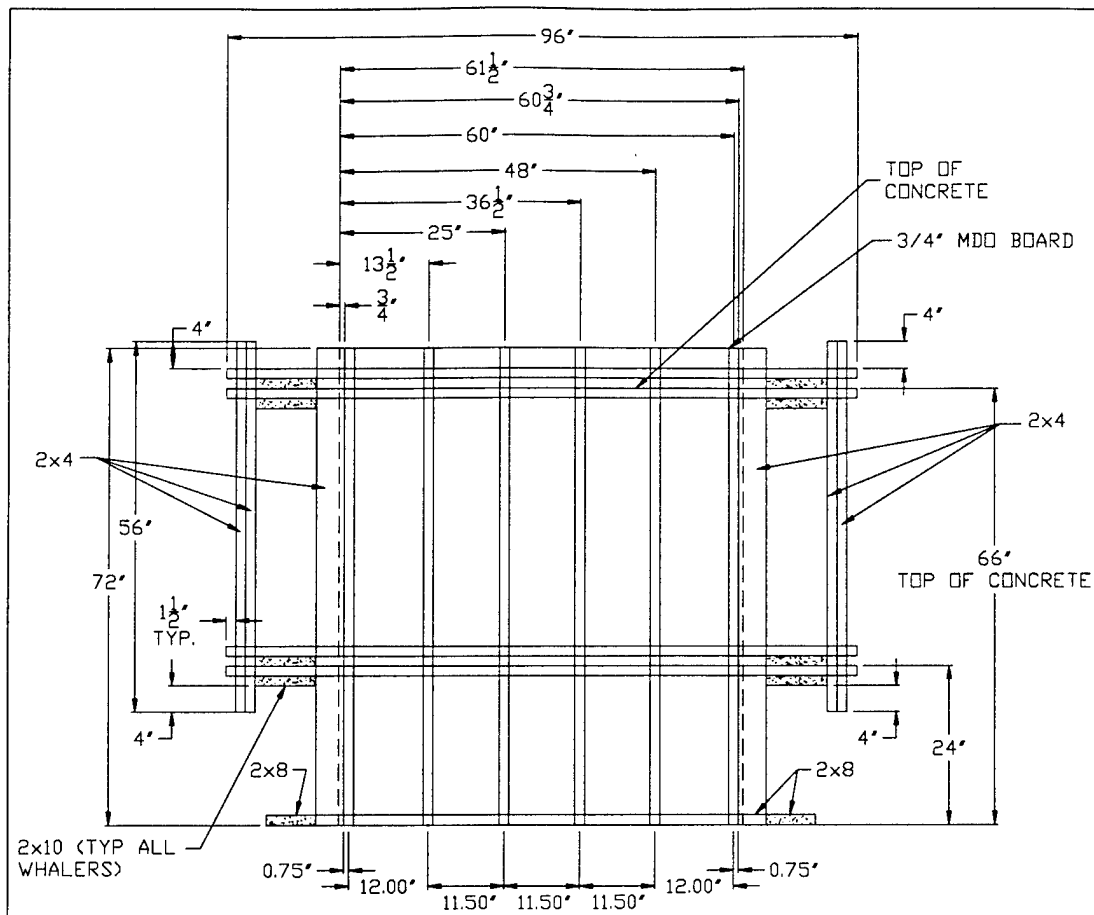
Figure A12. Side elevation view of the test block formwork.

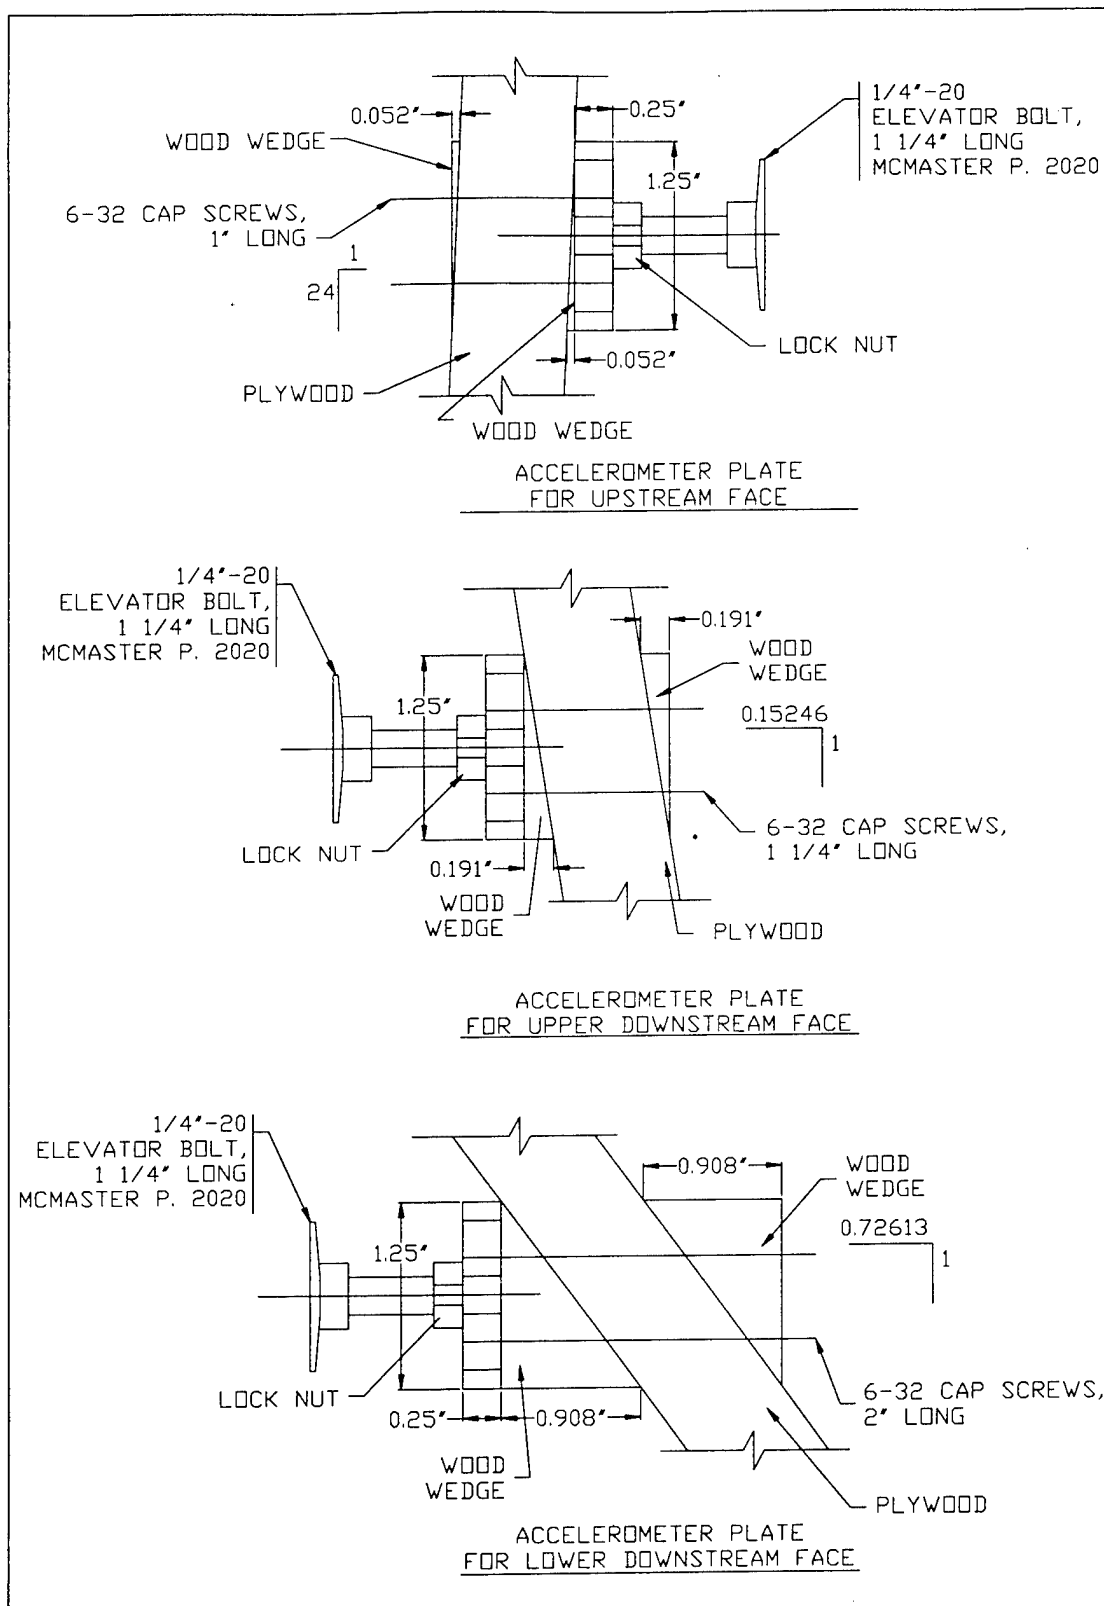
Figure A13. Elevation cross-section views of accelerometer plates for the upstream and downstream faces.

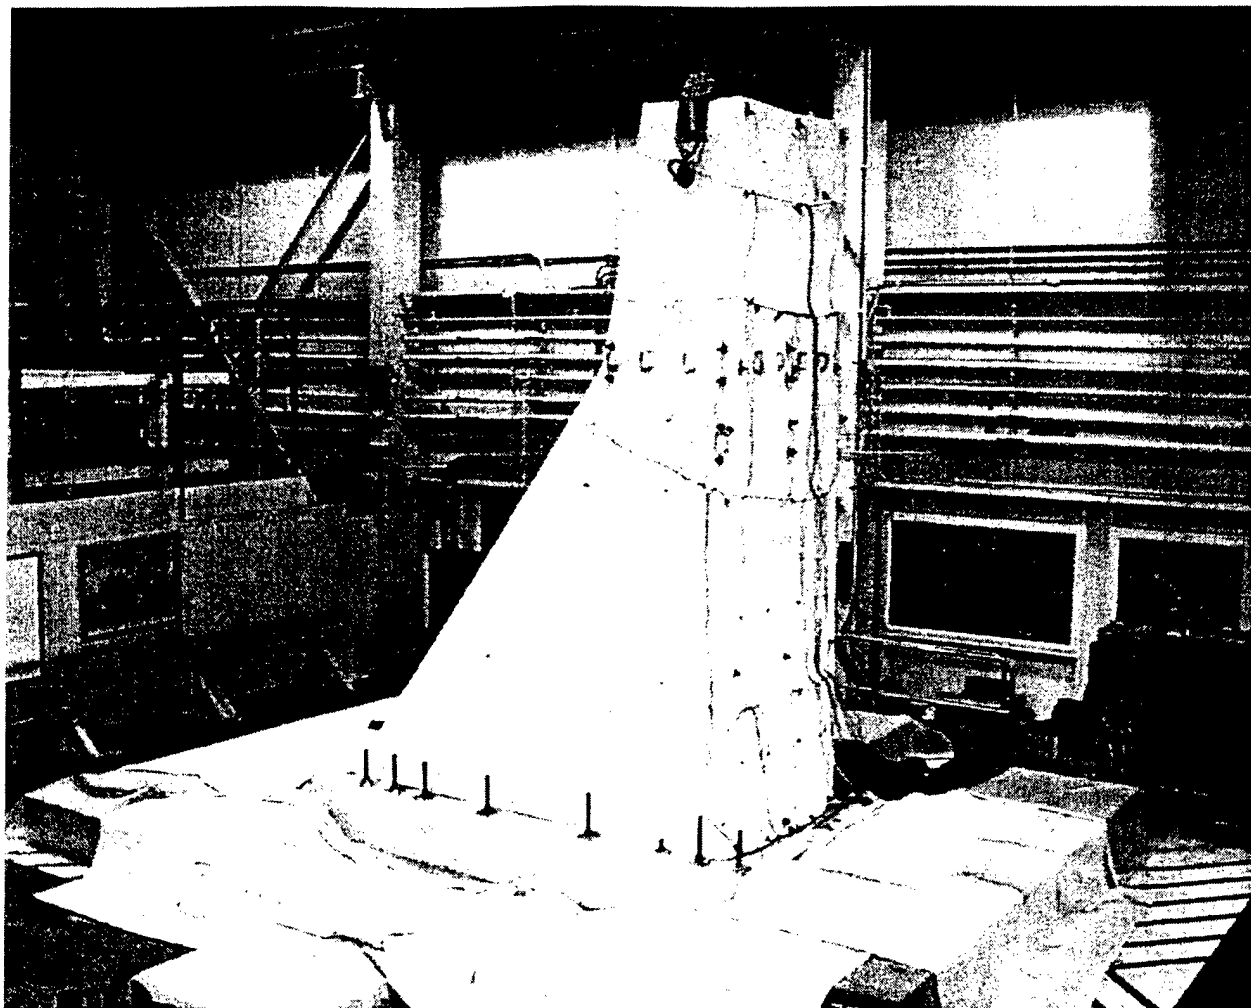
Figure A16. Model before testing showing TESS protection frame covered with plastic sheets and dropcloths.

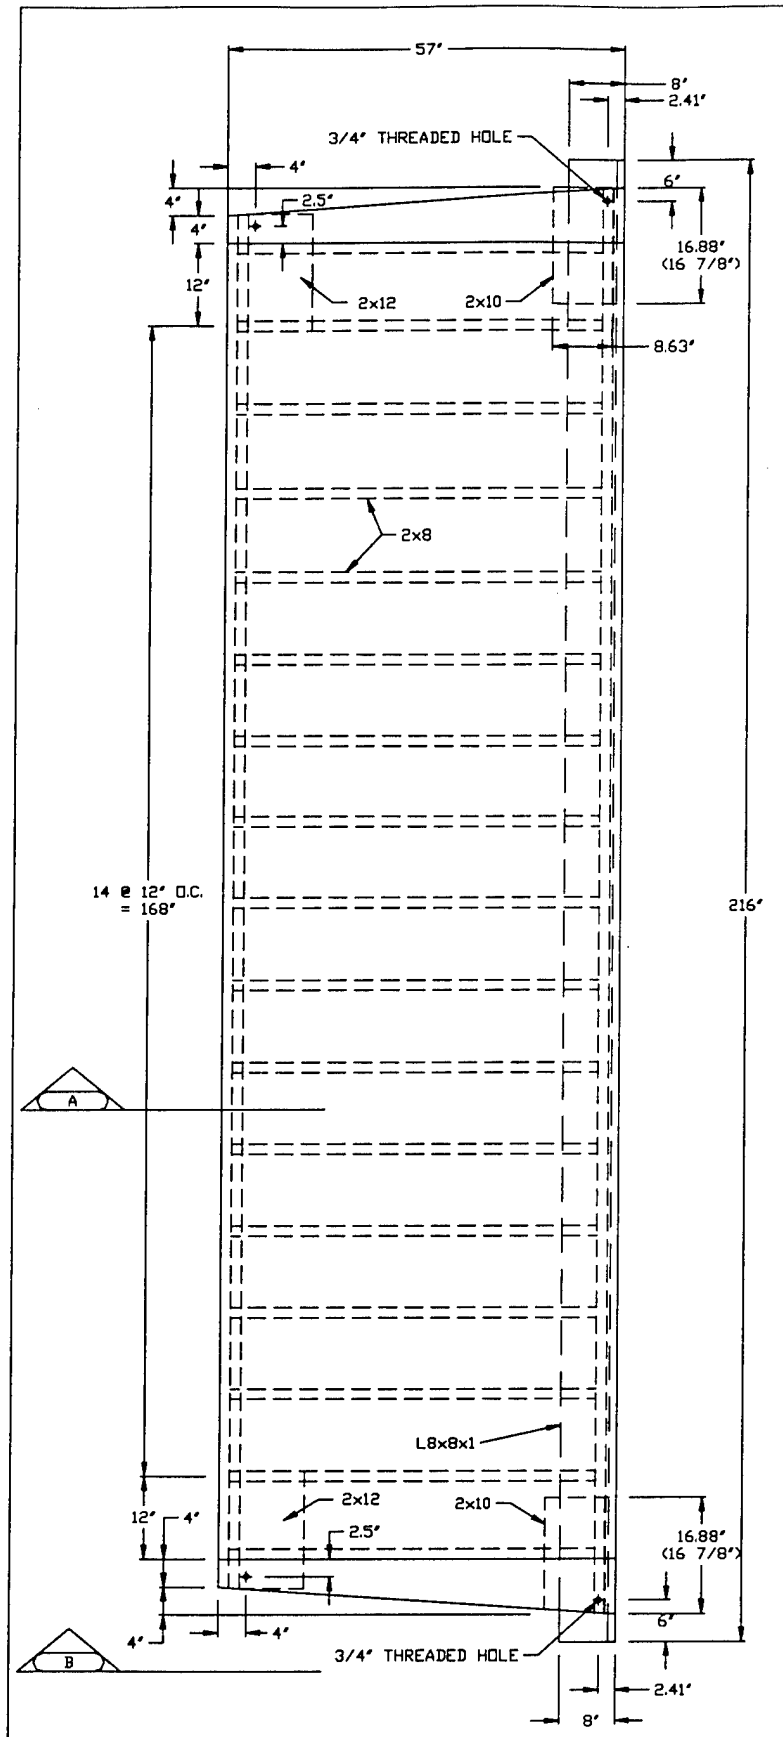
Figure A18. Plan view of north portion of the TESS protection frame.

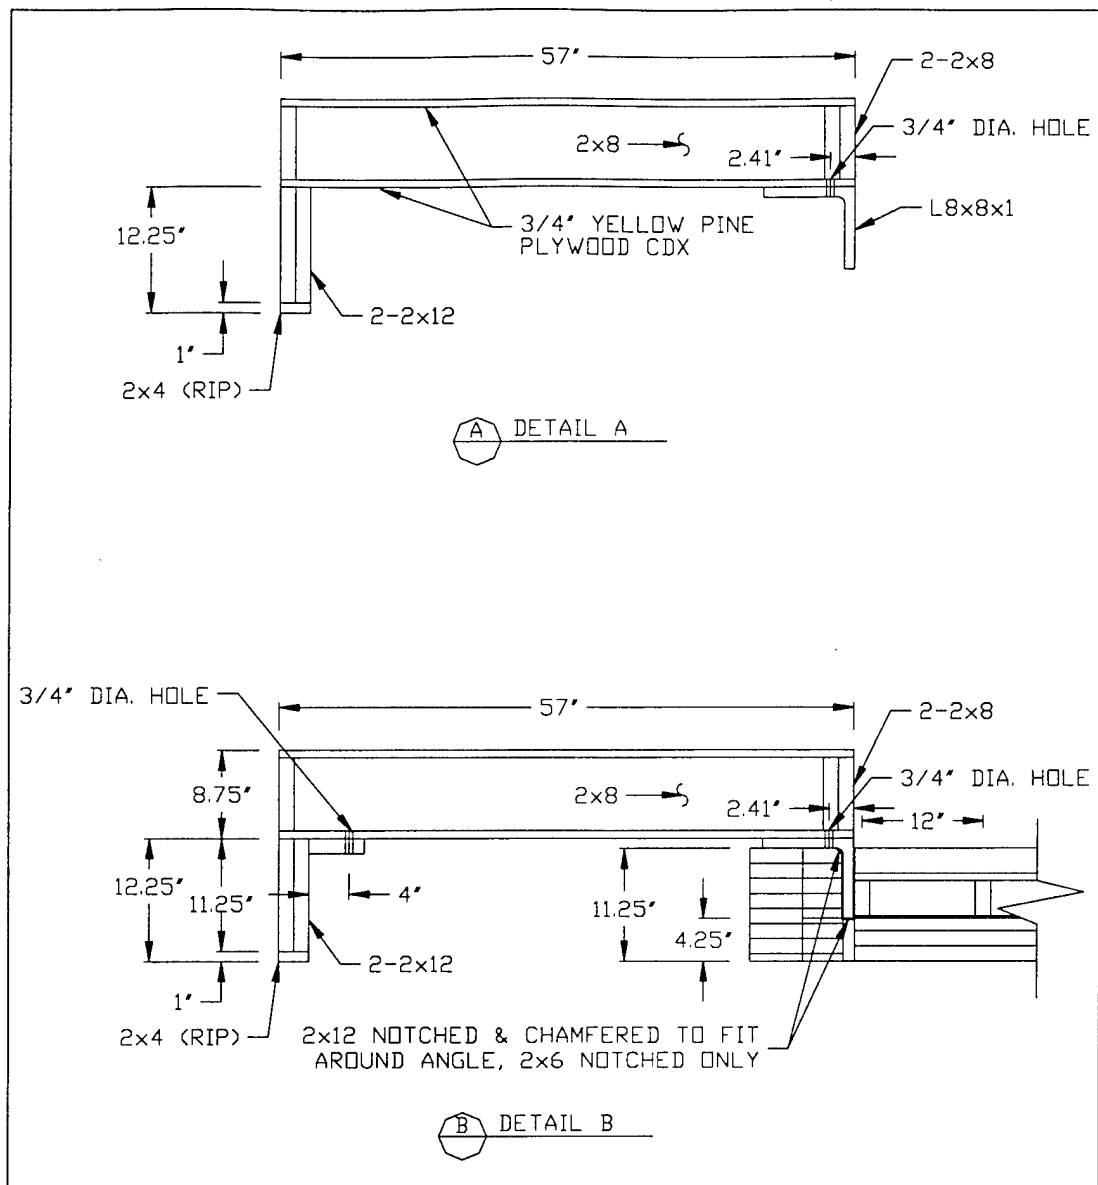
Figure A19. Cross-section views for north TESS protection frame.

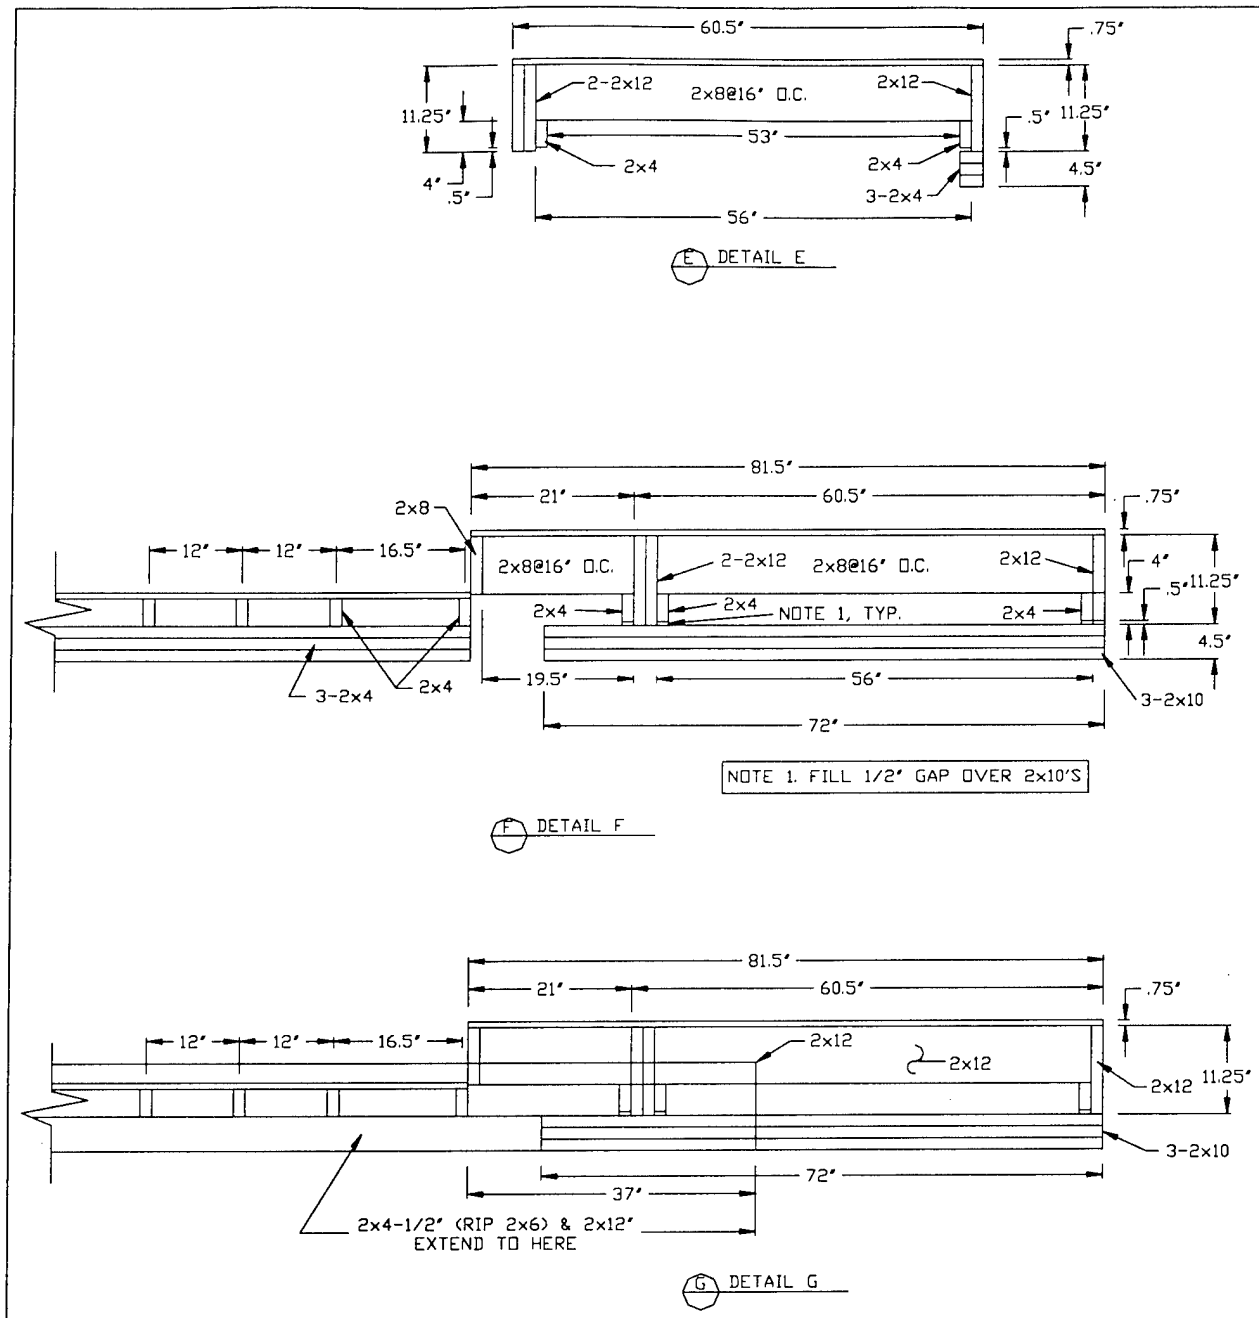
Figure A23. Cross-section views for south TESS protection frame.

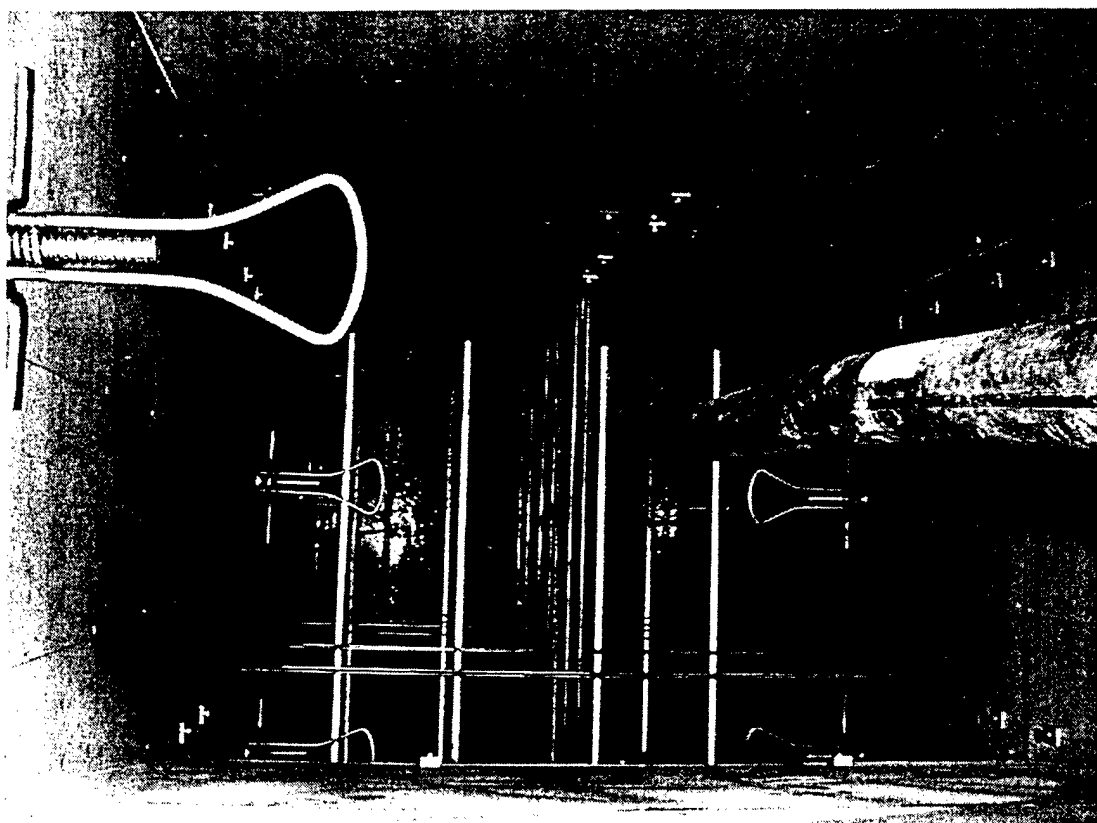
Figure B2. The rubber hose discharging material into the model formwork.

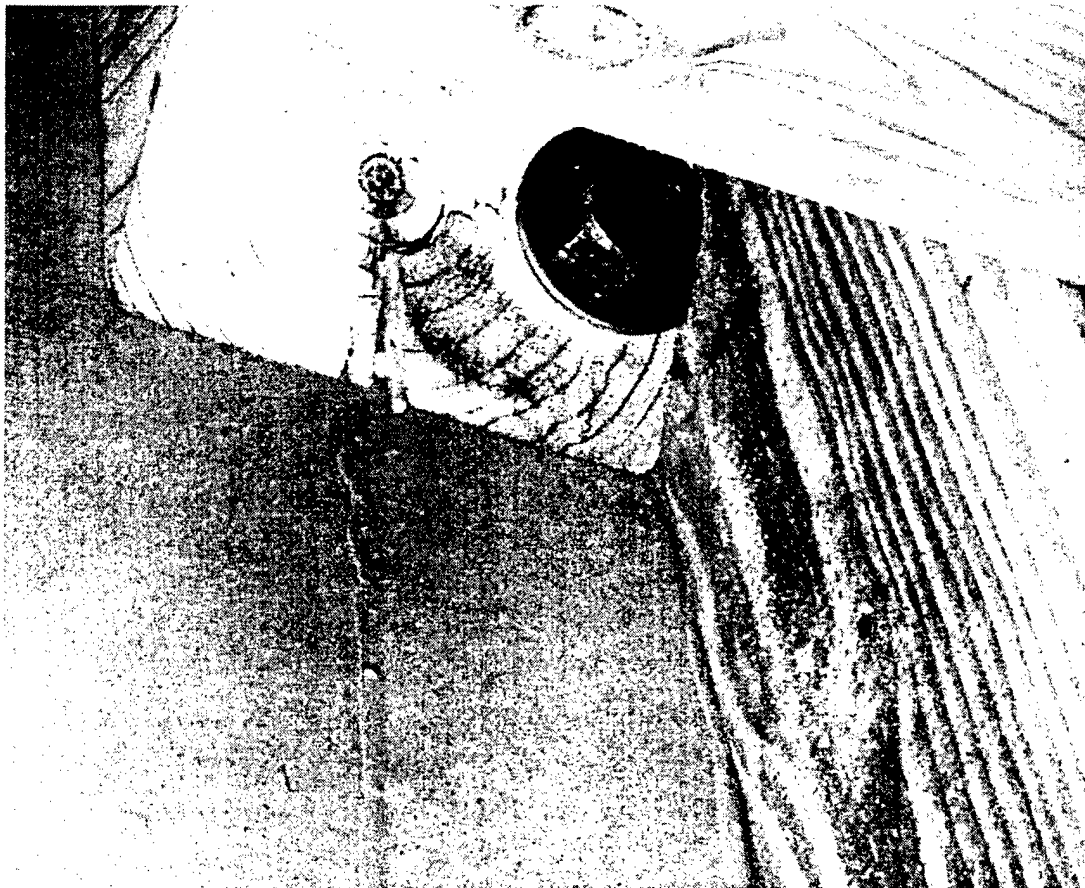
Figure B3. Leaks on the downstream face where a coil-tie bolt penetrates the formwork.

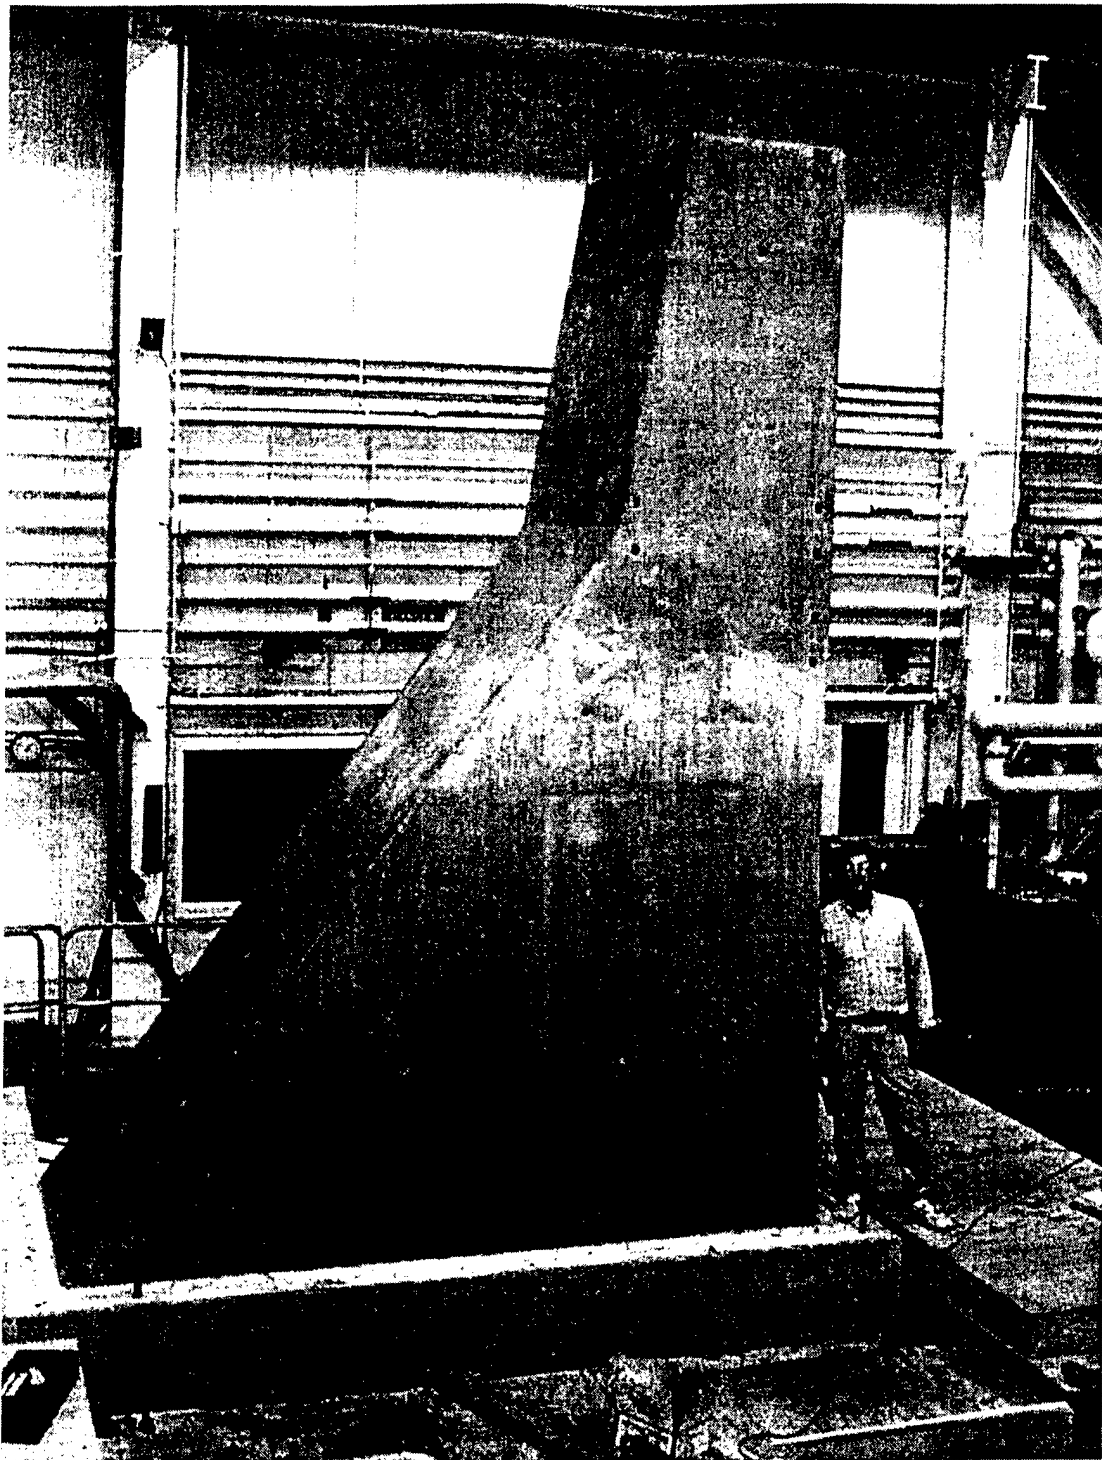
Figure B5. Back face of Koyna dam model after the application of curing compound, but prior to whitewash application.

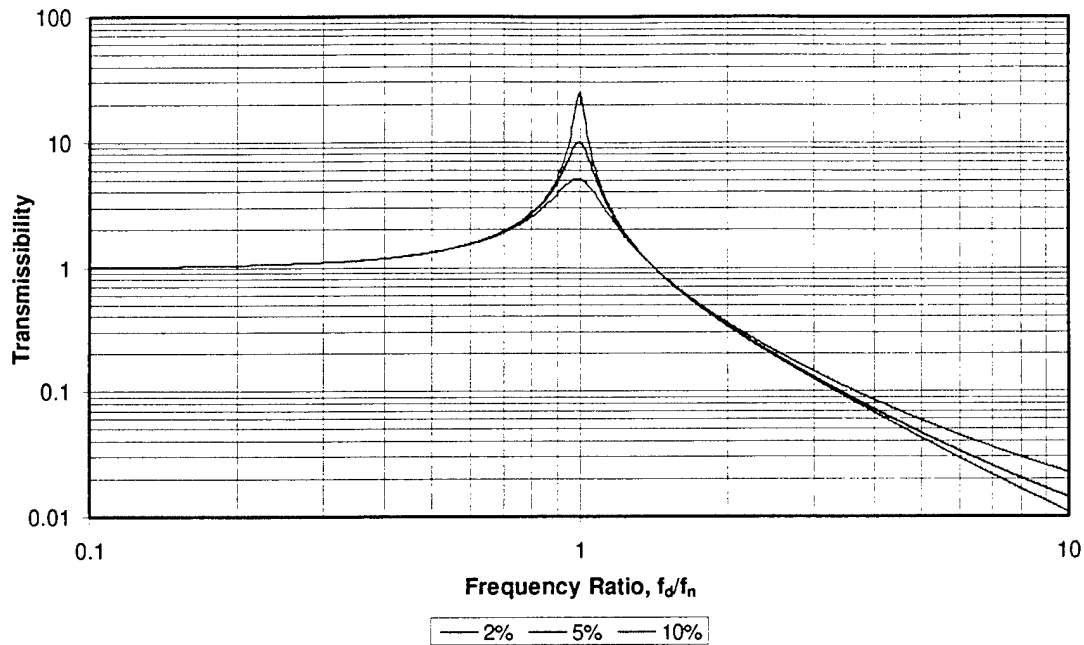
Figure C1. The response of a 13.2 Hz SDOF oscillator to harmonic motion.

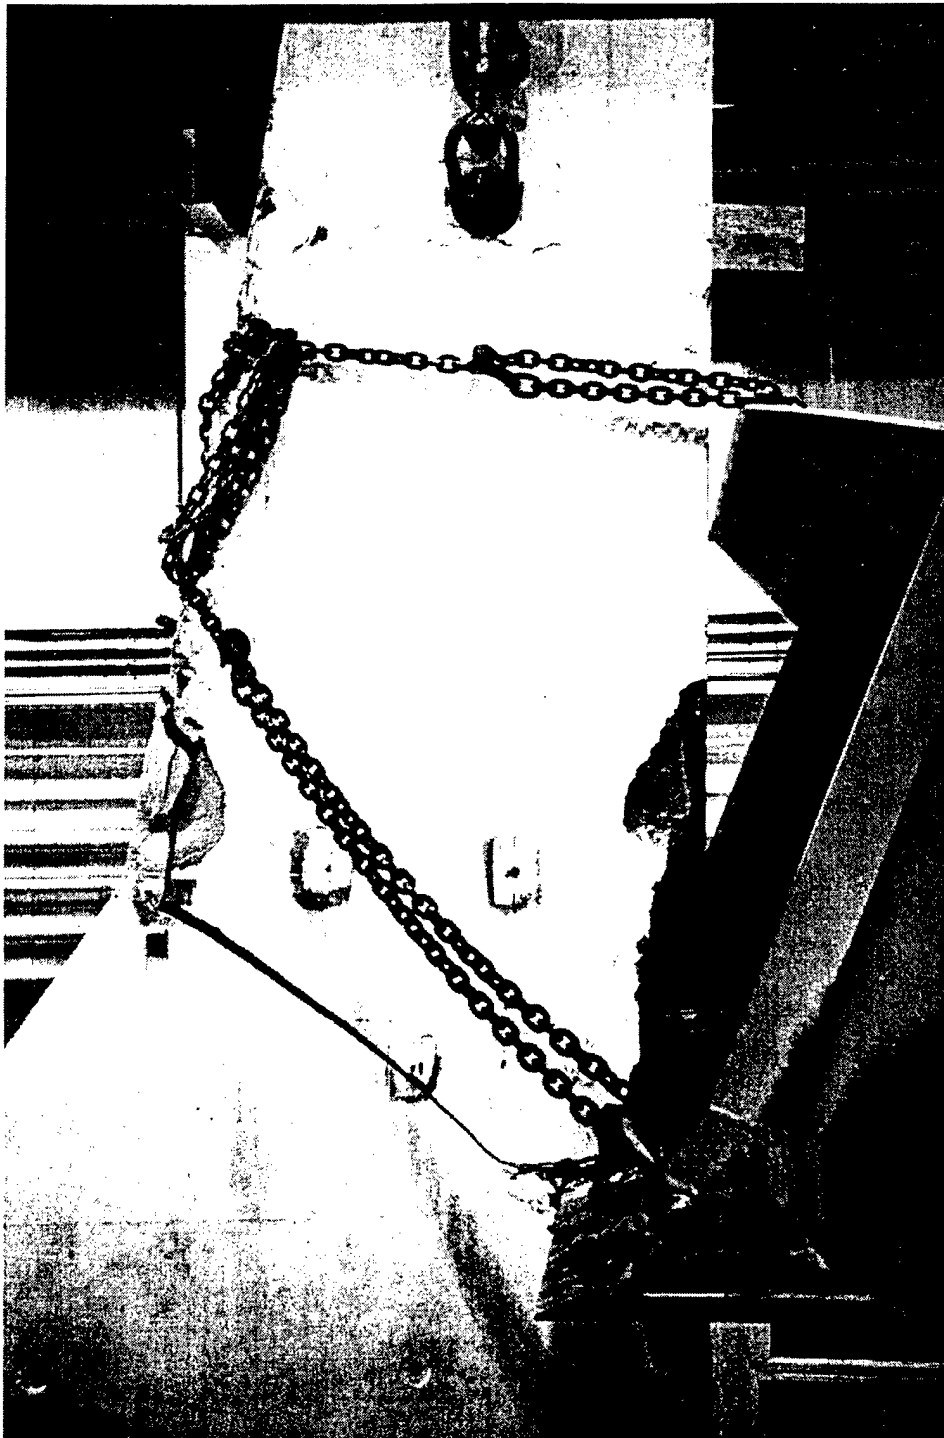
Figure D1. Removing top section of model with tractor and overhead crane.

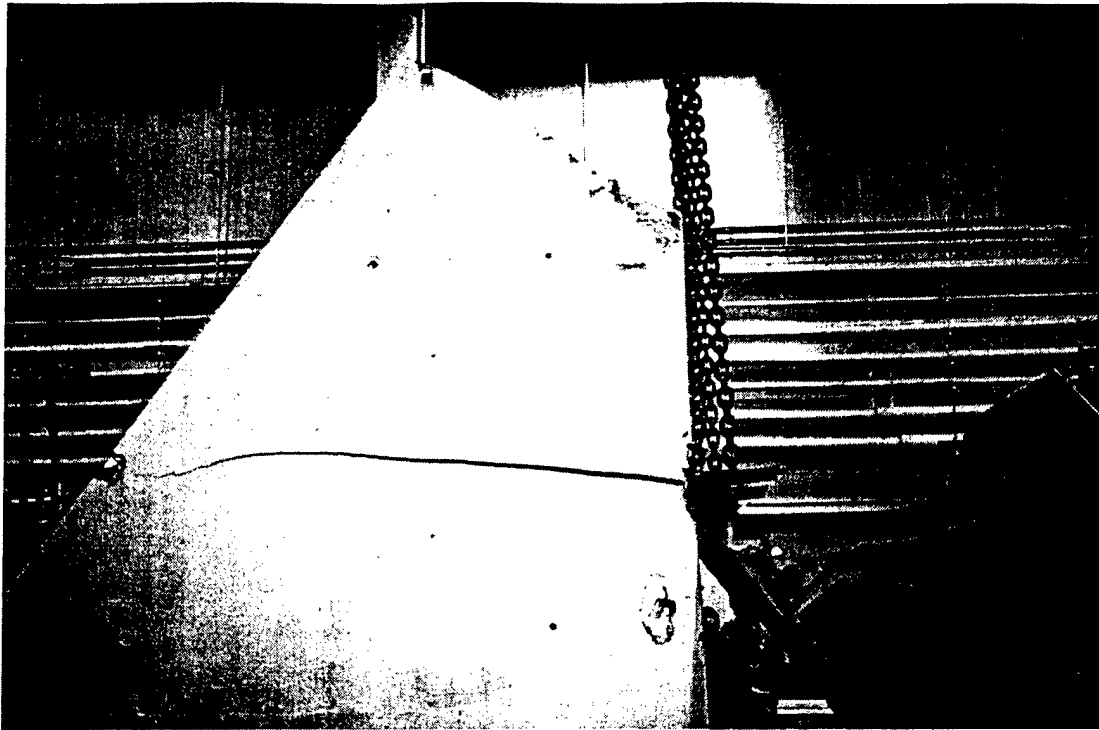
Figure D2. Lifting configuration for cracking along the top set of EMT tubes.

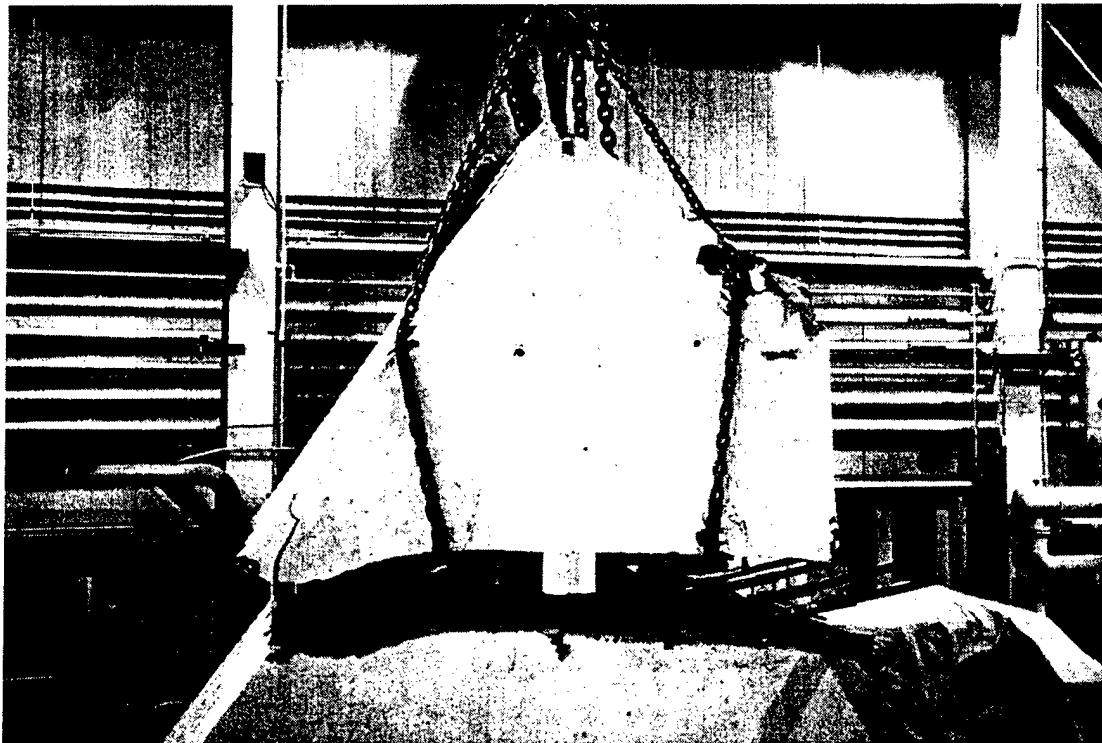
Figure D3. Lifting of the failed section of the model with the overhead crane.

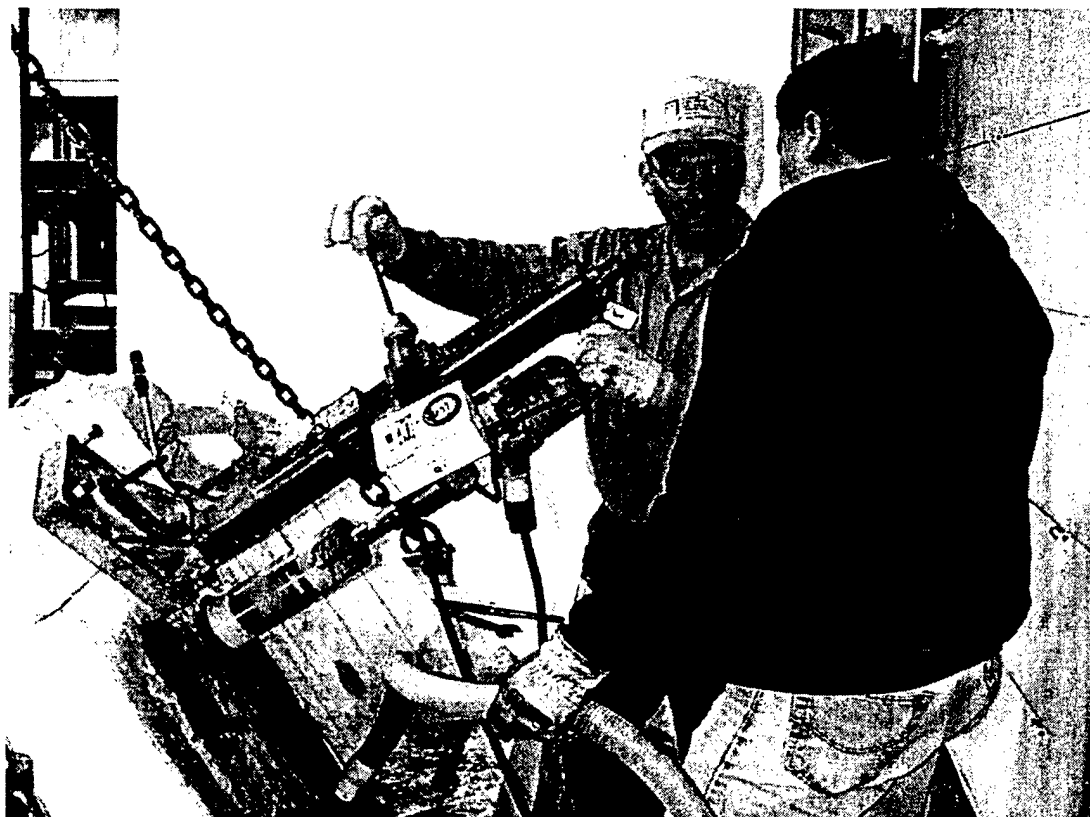
Figure D4. Drilling core samples near the base of the model.

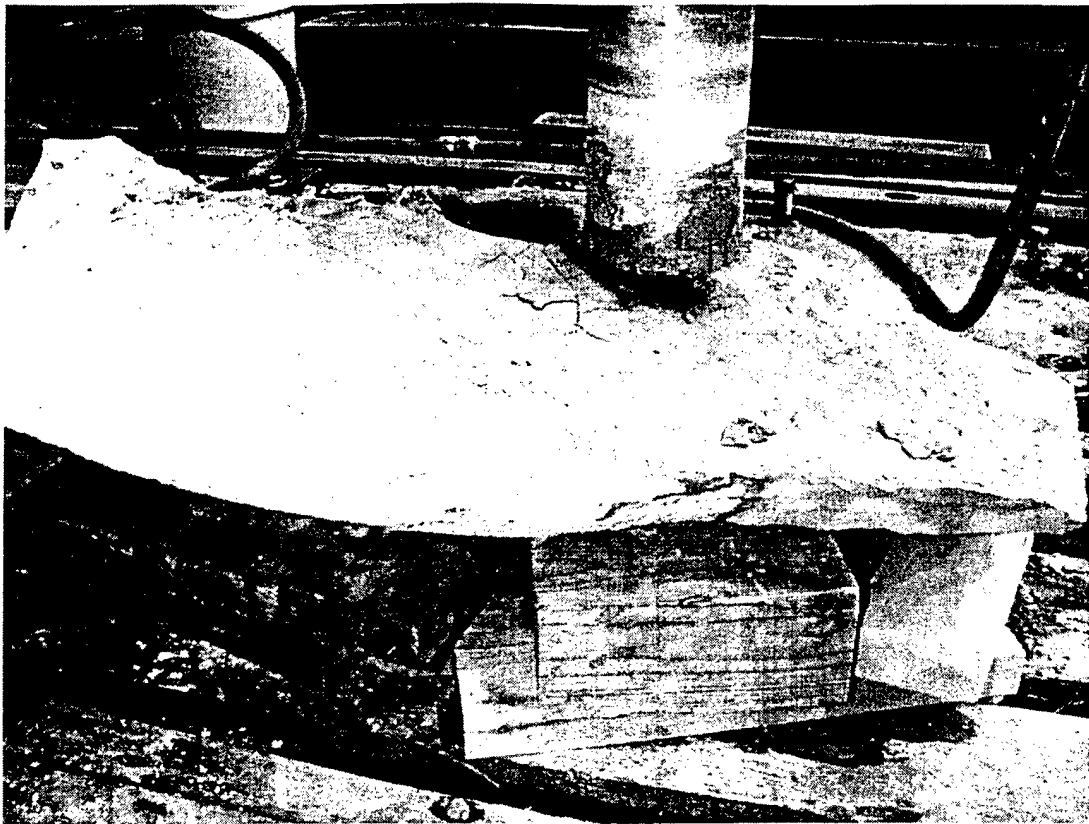
Figure D6. Drilling core samples from a section near the primary crack.
